Important
Safety
Information

**Do you have this type of
gas piping in your home
or business?**

Corrugated stainless steel tubing, or CSST, is a flexible pipe used to supply gas in homes and businesses.

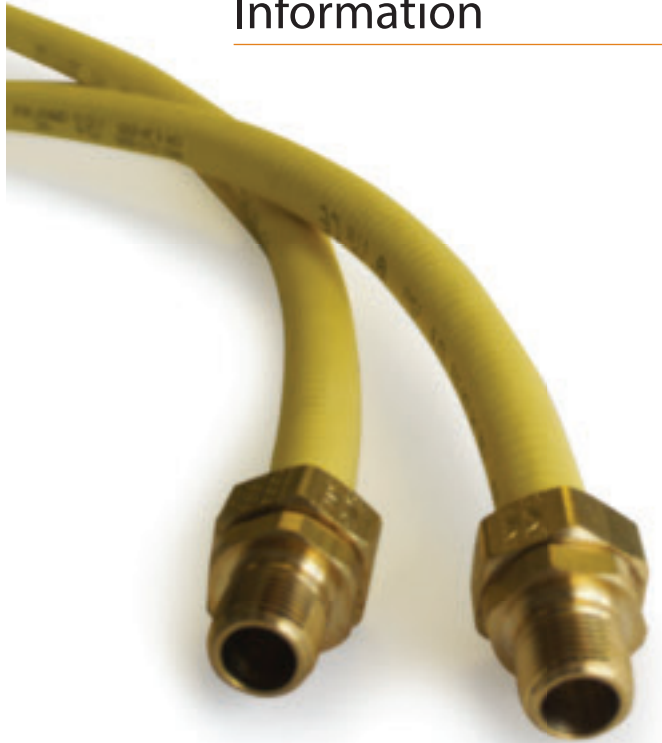
CSST has a yellow or black plastic exterior coating and would typically be present inside walls and through and along floor and ceiling joists.
